Nilsa opts for BioTector technology for the complete vision of the process

Problem

The WWTP of Tudela needed a reliable TOC / TN / TP monitoring solution at different points of its wastewater plant to obtain information in real time, since they periodically received high loads from industries connected to the network. These episodes could harm the effluent quality.

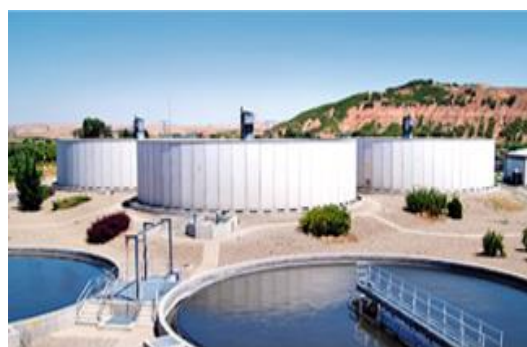
1. First stage biological filters

The WWTP process consists of a primary treatment with settling, and a biological treatment consisting of 2 stages of trickling filters with dedicated settling in each stage. Trickling filters are a robust and highly efficient solution for the treatment of organic matter, but they are not flexible enough to adapt to peak load situations and controlled nutrient removal.

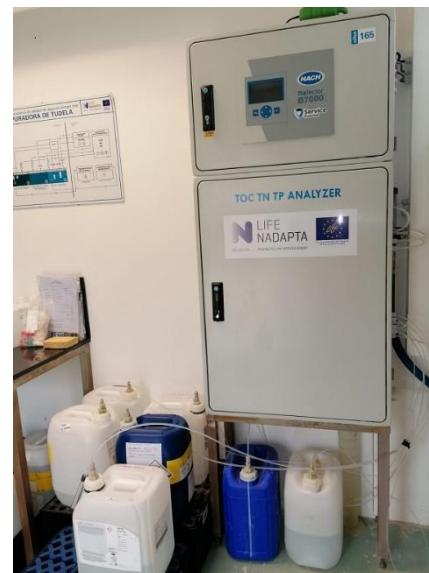
3. B7000 TOC TN TP Analyzer

Following an assessment of the plant and a thorough analysis of the TN, TP, TIC and TOC analysis results, Hach proposed the installation of the BioTector B7000 analyzer. This analyzer is capable of simultaneous measurement on three streams, allowing continuous monitoring of key plant parameters in real time for the feed water, intermediate process water and outlet water. The versatility of the BioTector B7000 analyzer, which allows the combined analysis of the 3 required parameters TOC, TN and TP, and with 3 possible measurement ranges for each parameter, offers a unique solution to the plant needs, constituting a system that allows the monitoring of the key process parameters at all points required by the customer.

Maintenance by the operator of the analysis system takes an average of 10 hours per month, including daily cleaning of the sample cuvettes and review of the condition of the analyzer, monthly verification of the TOC, TN and TP values, and bimonthly change of reagents with adjustment of the zeros of the different parameters.

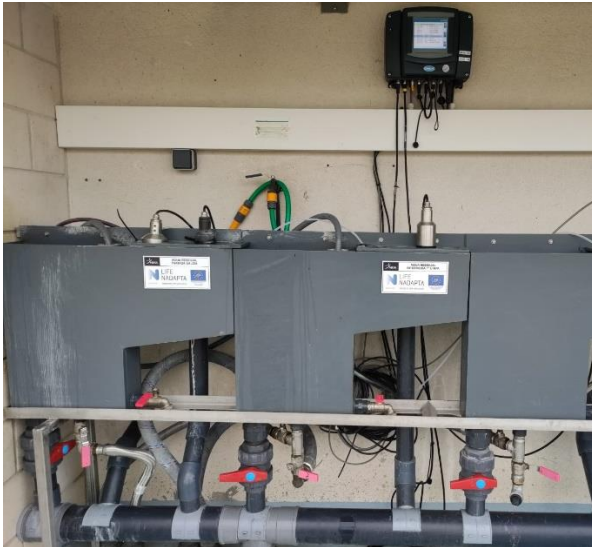
4. Sampling cuvette rack

For the implementation NILSA transported the samples from the plant inlet, first stage filter outlet and plant outlet, to a sampling system consisting of 3 cuvettes for the 3 streams of the BioTector B7000. Additionally, installing in the cuvettes other measurements such as pH, conductivity, solids, nitrates and membranes probes for the Filtrax system of ammonium analyzers. The sampling system together with the analyzer was initially placed inside a room of the control building, but this caused problems of S2H generation from the plant inlet sample, so NILSA proceeded to place the sampling rack outside the wall on which the BioTector B7000 analyzer was placed. Figures 3 and 4 show the installation of the analyzer and sampling system. Figure 5 shows the synoptic with the set of measurements performed in each sample stream.

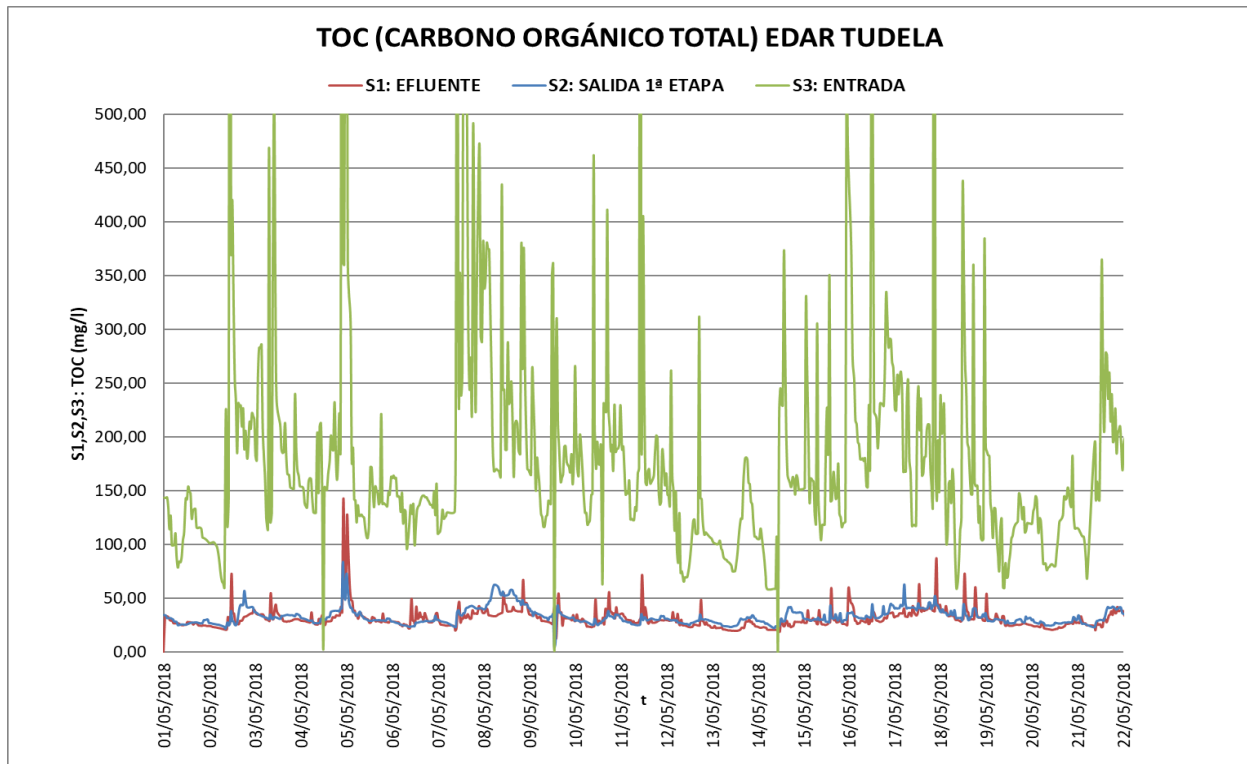
6. TOC in inlet, 1st stage outlet and effluent

Since the installation of the analyzer in April 2018 it has provided relevant data for plant management, proving to be a robust system with high uptime of measurements. After the first weeks of operation the historical measurements allowed to identify the problems of point discharges with high organic and phosphorus loads. In addition, the existence of real time data of the 3 parameters in inlet, 1st stage outlet, and plant effluent allowed an exhaustive knowledge of the behavior of the biological filters. Thus, verifying the high performance (70 - 80%) in the reduction of the first stage, while the nitrification process was developed mainly in the second stage with ammonium reduction of 70%. Figure 6 shows the TOC results at the three points measured during the month of May 2018.

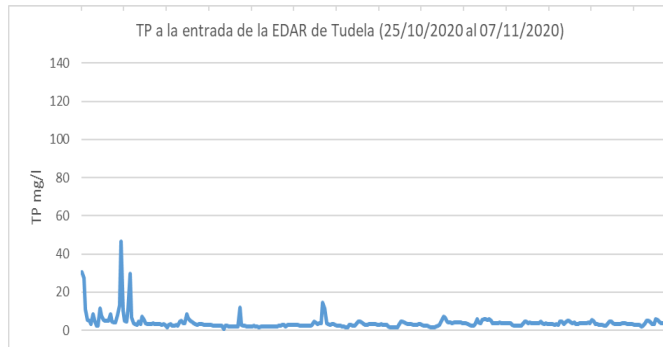
8. Current inbound TP concentration

Figure 7 shows the concentration of Total Phosphorus at the plant inlet during the same period. Peaks with a high concentration can be appreciated, which respond to episodes of uncontrolled discharges. The rapid detection of these episodes made it possible to identify their origin, thus avoiding their repetition. Figure 8 shows the current profile of Total Phosphorus concentration at the plant inlet, where the great progress obtained compared to the previous situation can be seen.
